# Hare Hill House & Carnegie Library

Internal Survey

March 2010

This is a brief survey of each room in hare hill I house and the Carnegie library to establish those items of originality which are thought to be worth preserving or restoring

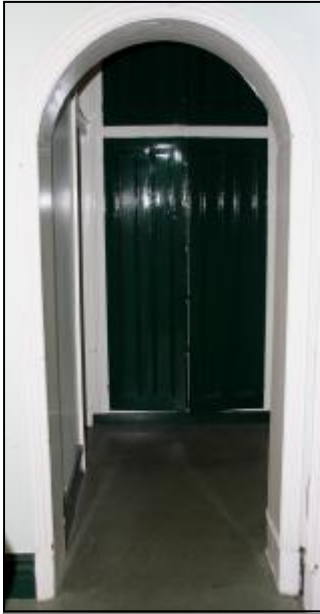
Accessed from the top of the main staircase through an arched opening to the left of the landing. It leads to the 'servants' staircase and contains floor to ceiling cupboards. The cupboard doors are panelled and will be of some age but it is unknown if they are original to the house. Keep if possible.

Arched opening from main stairway

The arched opening should be preserved.

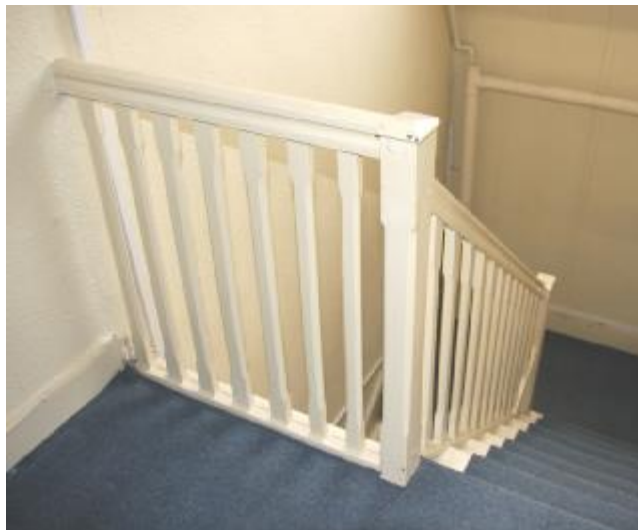
'servants' staircase containing what is thought to be the original balustrade which should be retained.

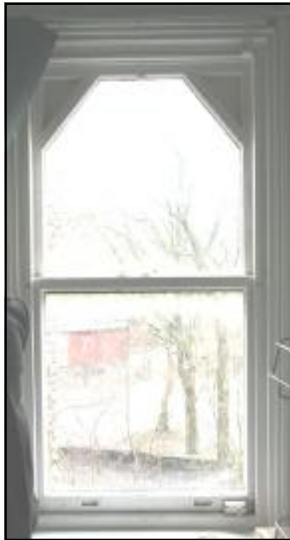
Accessed from the top landing of the 'servants' stairway it contains a roof light to the north and a window to the east. It has exposed roof structure in one corner.

Window shape reflects similar shape elsewhere in the building

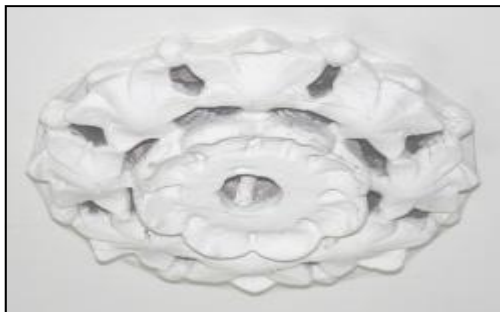
Plaster coving

The plaster coving is moderately elaborate by today's standards and is typical of all covings on the second floor and should be kept and repaired as necessary.

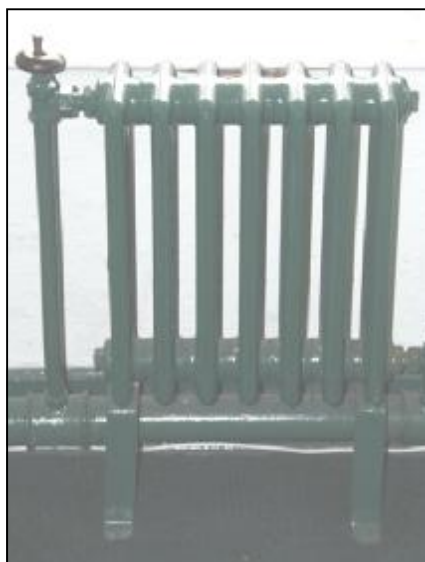
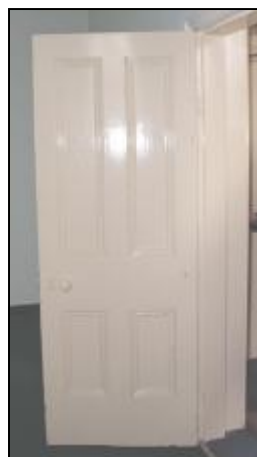
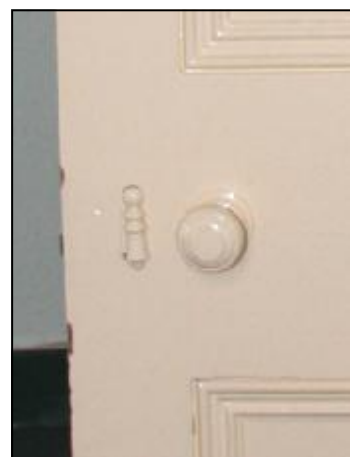
Ceiling flower

there is an odd ceiling flower over the window which is repeated in some other rooms. Its purpose is unknown but could be a ventilation grill or a gas outlet? The material it is made of is not clear because of many layers of paint. It could be plaster or cast iron.

Original panelled doors and furniture should be kept (or copied where missing).

Radiators are of a variety of types and ages but one thought was to preserve the old style cast iron type in any refurbishment.

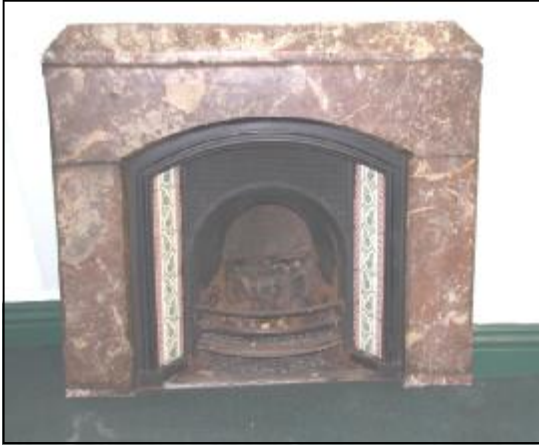
This room is accessed from the corridor (room eight) and from room seven. In addition to the details recorded for room six it has a fireplace worthy of retention although it is not known if it is an original. It has exposed roof structure in one corner as in rooms three and four.

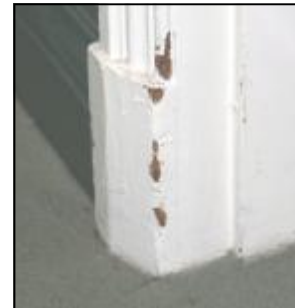
This is the access corridor from the stair landing accessing rooms seven, nine and ten. A minor note is the skirting stop used where the skirting meets an architrave which should be retained and used elsewhere when necessary.

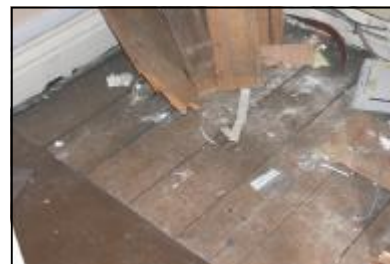
This room is accessed from the corridor (room eight) and should have the covings, skirtings etc. retained or replaced to match those elsewhere on the second floor. This was one of the few places where the original non-jointed (t & g) flooring was visible; if possible this feature should be repaired and retained.

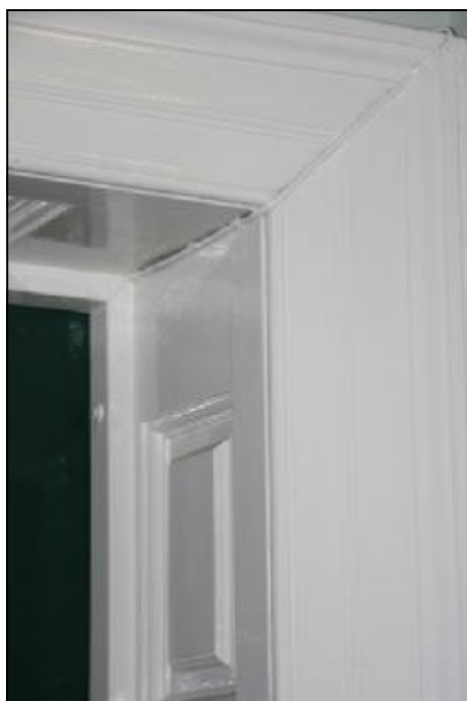
This is the main staircase and landing. The access doors are mainly original with large architraves and panelled door linings which should be retained. The stair skirting matches that on the second floor (see picture in room five). There is no skirting to the landing itself and this can perhaps be redone. The coving to the landing matches that over the window.

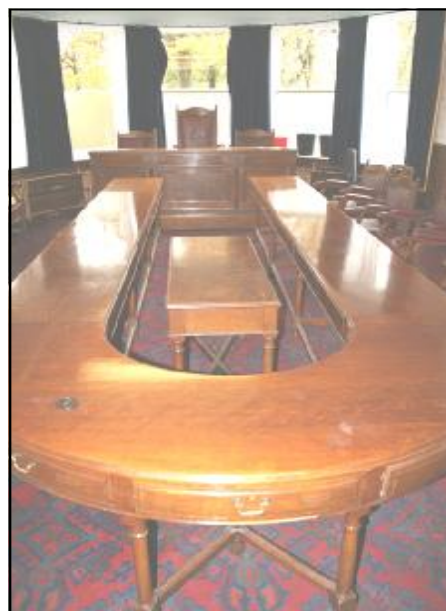
It has not proved possible to investigate the state of the old ceiling above the false one more recently added but it is hoped it will have kept the old plaster covings. The false ceiling must be removed and the height and design returned to the original. The window glass is acid-etched with the initials of the Littleborough urban district council within a

pleasing design. Where this has been broken it has not been retained; the plain glass should be taken out and replaced with acid-etched glass to match the original. The heating radiators may be considered worthy of retention where the pipework has been curved to match the semi-circular end wall.

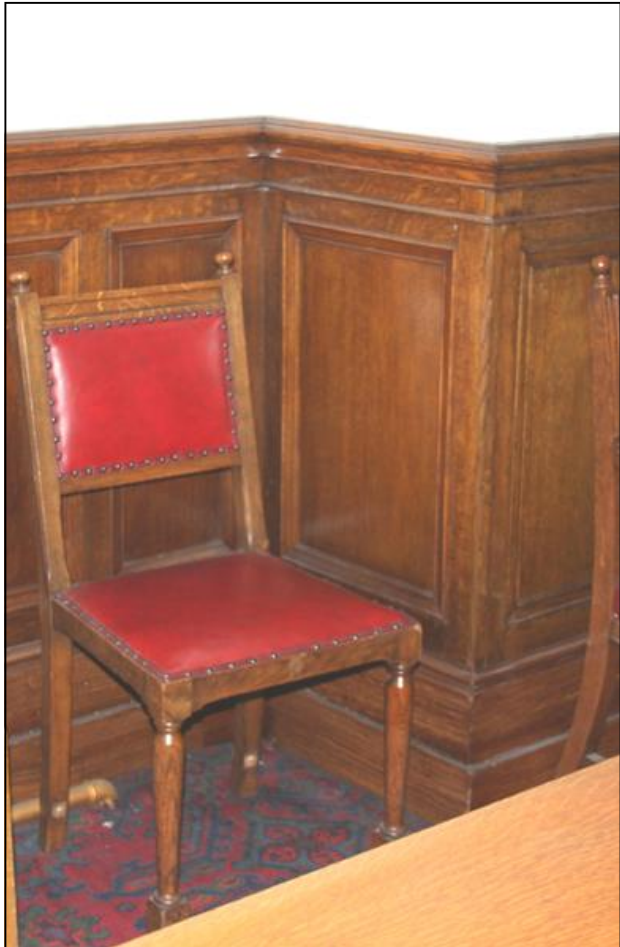
Wall paneling

Some damage has been done to the paneling in places due to unsympathetic alterations and additions, particularly in regard to electrical work, but this should be repaired.

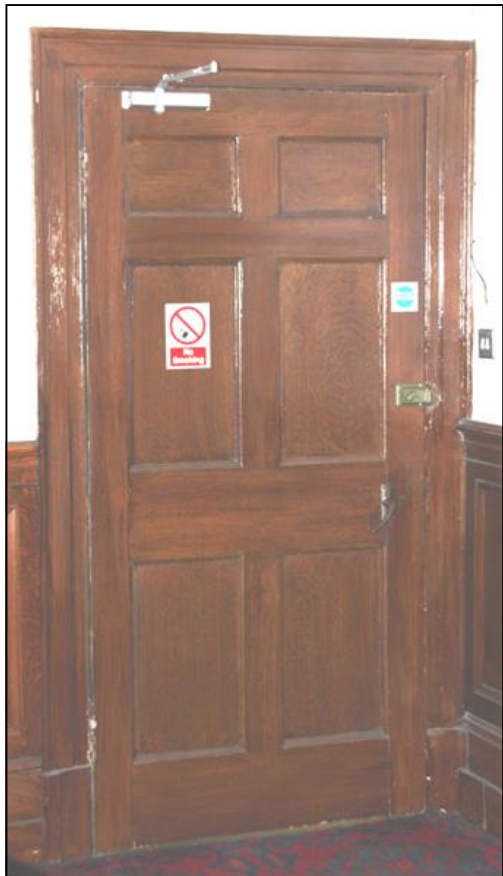
Entrance door with original paneling and architraves but all original door furniture has been removed.

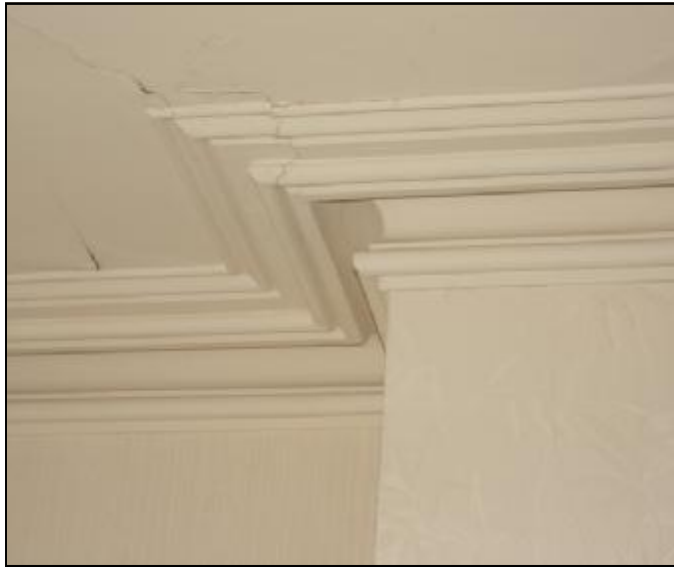
This room is on the left hand side of the front elevation and has sliding sash windows with elaborate architraves and paneling worthy of retention.

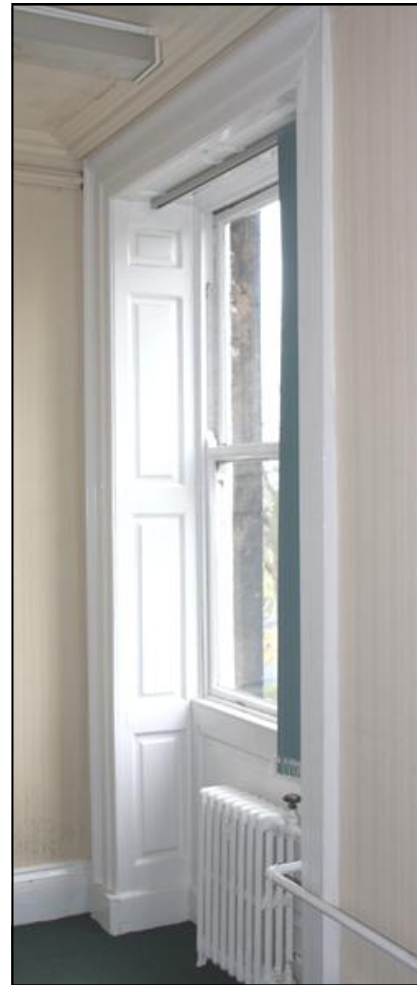
There is evidence of water damage to the plasterwork.

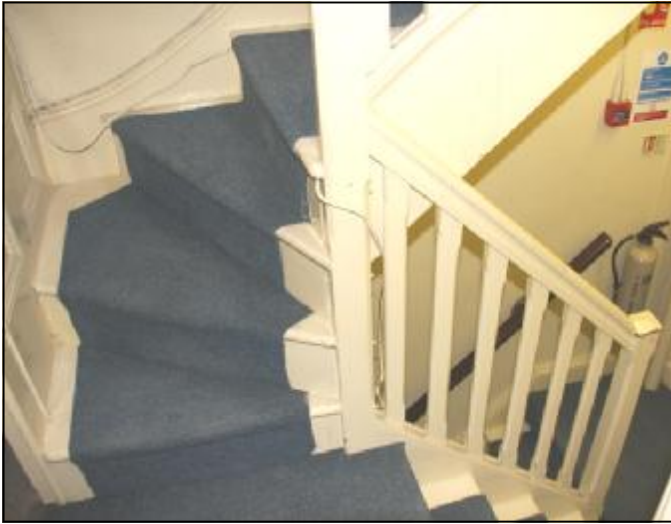
This is the 'Servants' staircase and landing. There is an odd, partially obscured, curved wall between the space leading to the gents' toilet and the ladies' toilet. It is not known why it is so or whether it is original or not. If original it would suggest that rooms twenty and twenty-one were always two rooms particularly as the wall between them is solid.

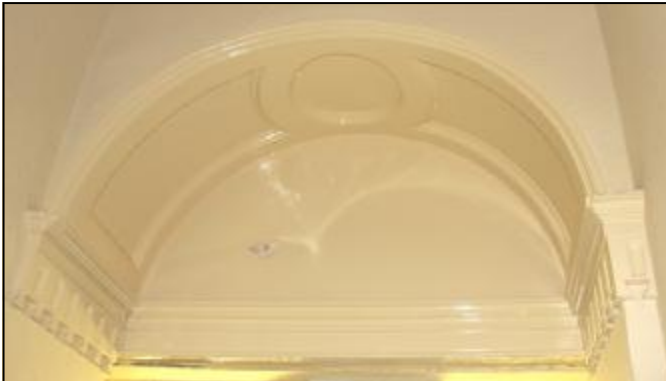
In addition to connecting the ground and first floors it also leads through an arched opening to what is believed to be a later addition to the original plan of the house albeit in matching and appropriate design; it is felt that this was built while still in private ownership.

The arched opening appears to be in good condition and must be retained.

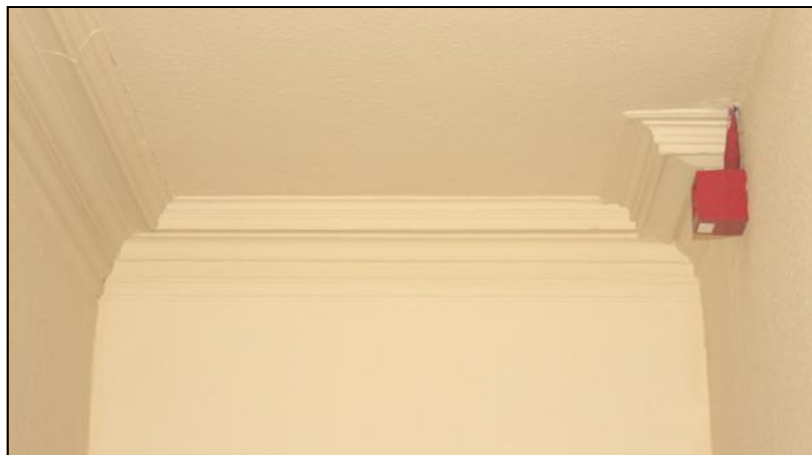
These rooms were originally one room as evidenced by the coving in the corridor (room twenty-four) 'vanishing' into the new wall which divides it from twenty-three. A corridor may now be considered essential and to be retained, in which case covings and skirtings should be continued along the corridor wall on both sides.

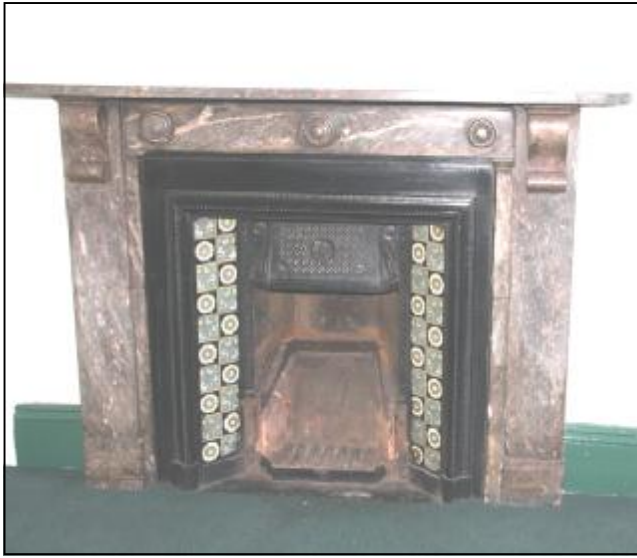
Room twenty-three contains a fireplace which is probably original and should be retained.

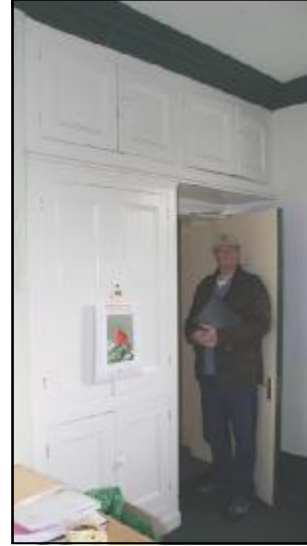
Cupboards in the wall dividing this room from the adjacent room (twenty-five) also appear to be original and should be retained.

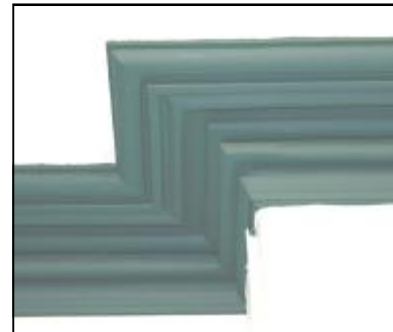
The plaster covings are more elaborate than those of the two floors above and should be preserved and repaired as necessary.

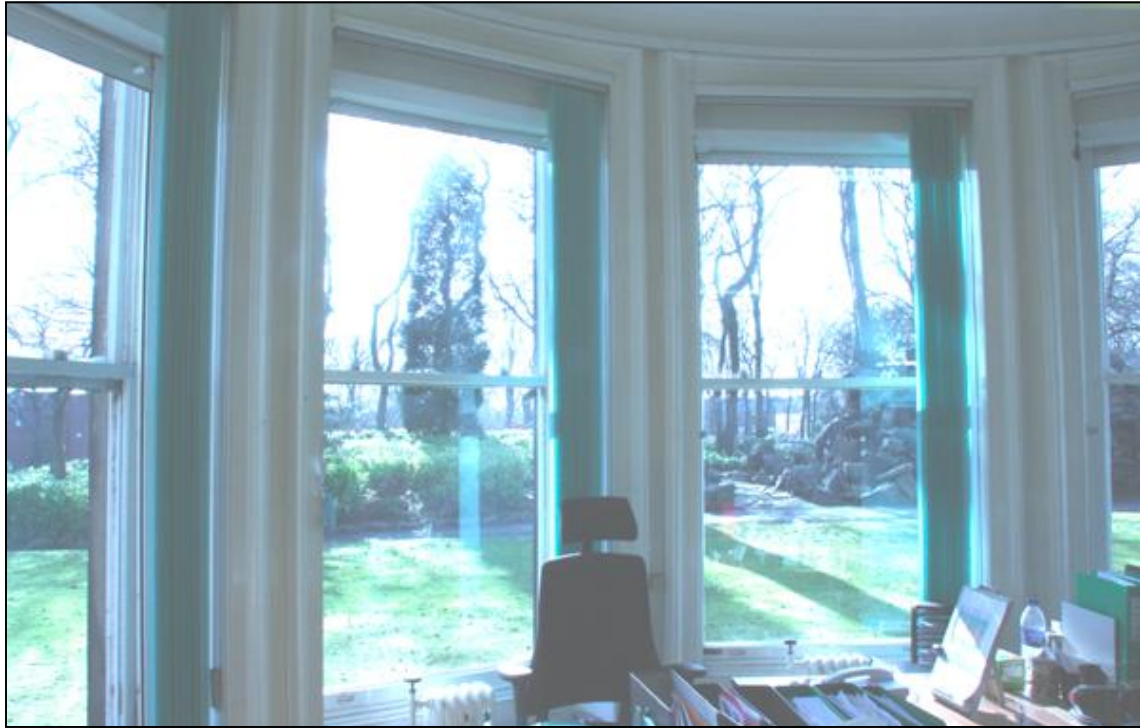
The west facing wall is semi-circular as are those on the floors above with sash windows.

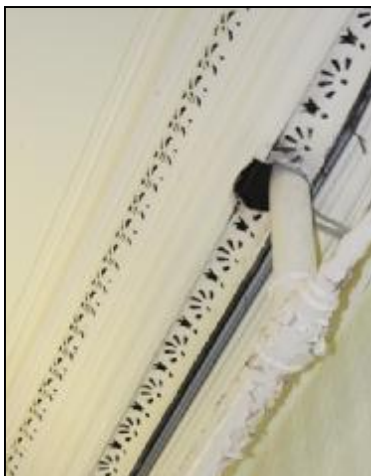
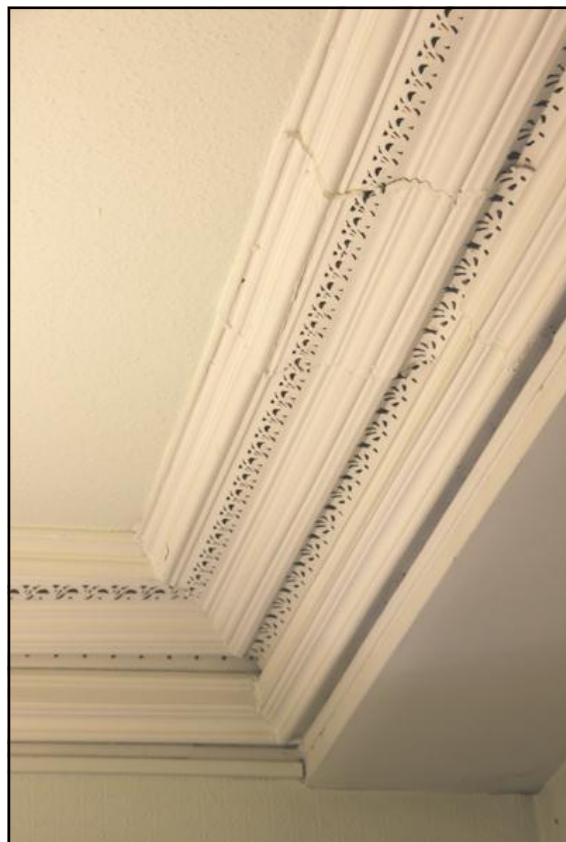
Separate coving details of an elaborate nature not found elsewhere in the house indicate that this room may have been the principle 'receiving' room for visitors.

While this coving has been severely damaged by a number of unsympathetic additions to the house it is considered worthwhile repairing it if possible.

It is clearly not completely made of plaster moulding but the other material(s) used are not known.

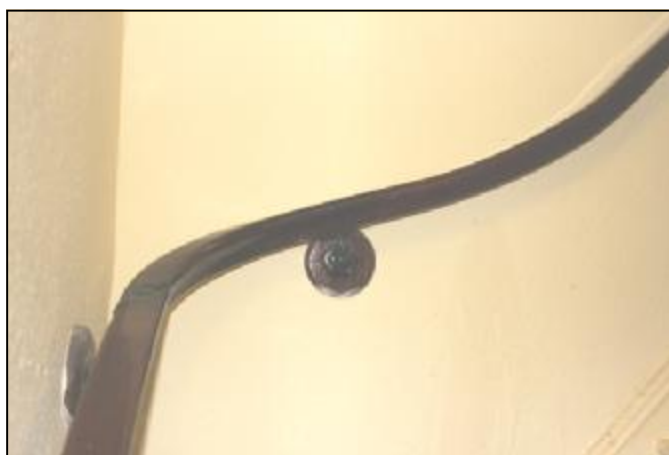
Servants' stair handrail detail

A corridor leading to what is thought to be a later extension containing rooms thirty-two and thirty-three on this floor. It also gives access to the 'servants' stairs to the upper floors and a separate stair down to the cellars.

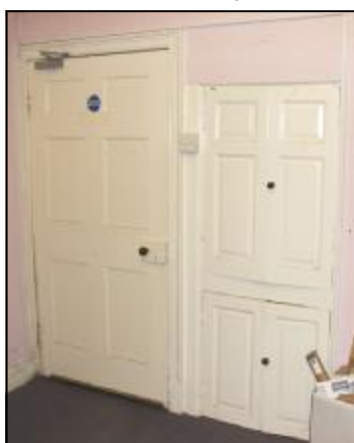
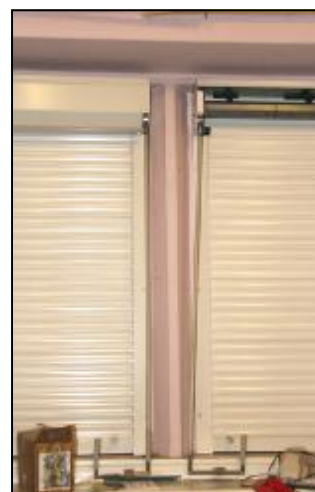
This is one of two rooms in the extension. It does not appear to have any of the original coverings or skirtings.

The window has a stone mullion. There are built-in cupboards in the internal wall which are thought to be original and although of no intrinsic value could be repaired and kept if useful.

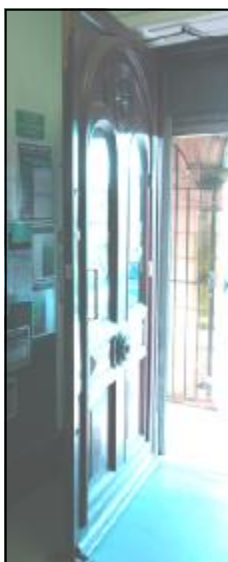
The entrance door itself, while not necessarily the original is of some age and extremely attractive and should be retained.

Its full charm cannot be appreciated from the outside due to the addition of an ugly shutter cover which hides the top. This should be removed completely and if protection is felt necessary it might be in the form of substantial but attractive metal gates.

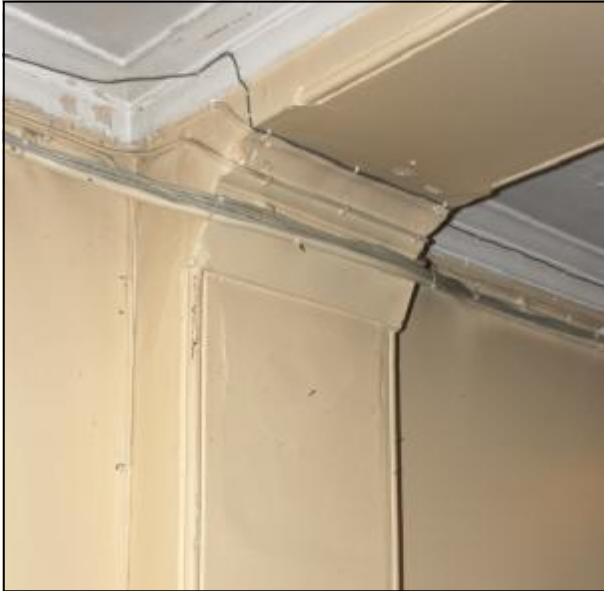
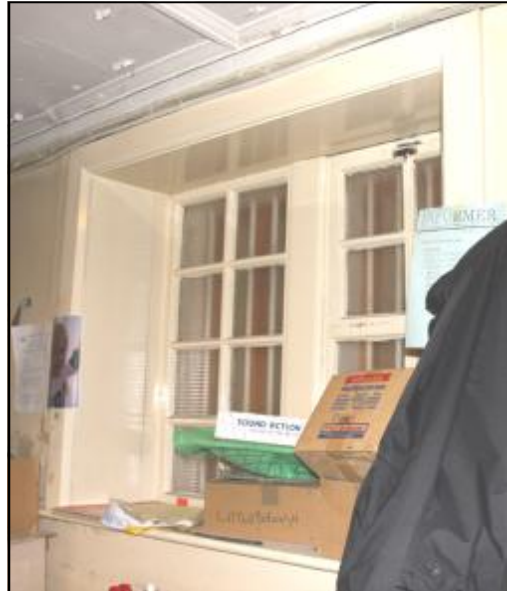
There are two sets of pilasters and shallow beams at regular spacings from the entrance doorway from the house. The plasterwork is simple but worth repairing after removal of extraneous wiring.

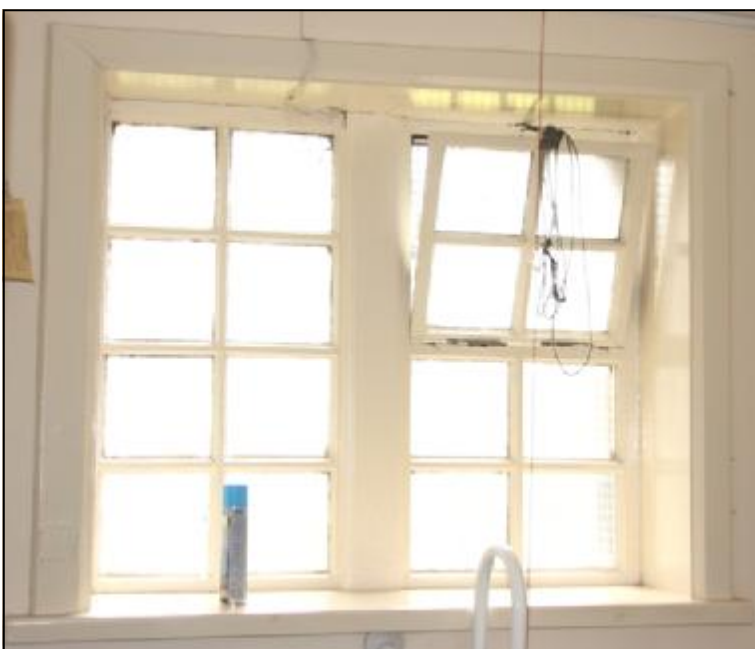
One of the disabled toilet rooms; this one is intended to serve the house/council offices. It contains a matching window to the one referred to above in the corridor. Although it is presumed that this was built at the same time as the library it has little to recommend it internally.

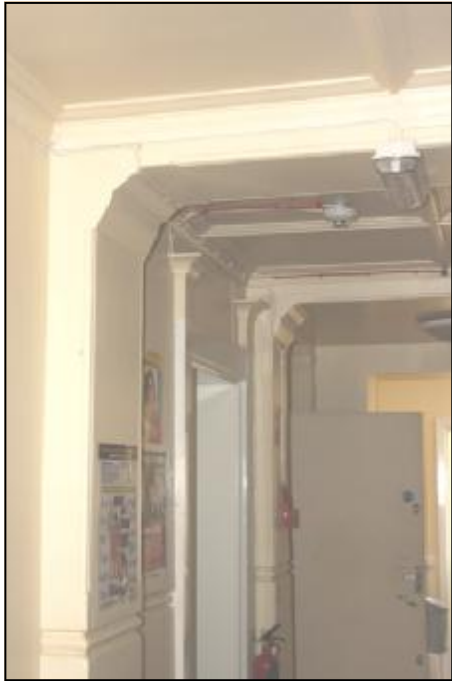
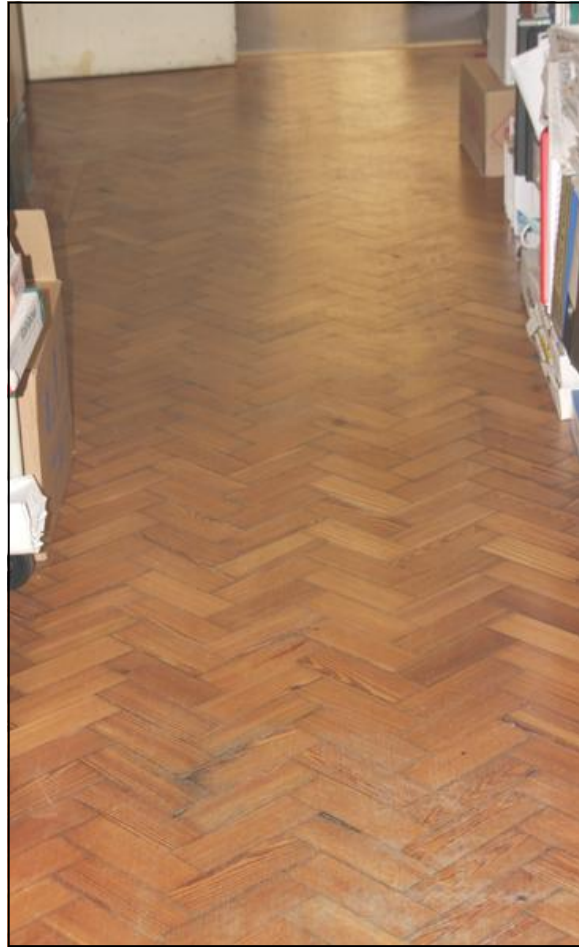
A continuation of the corridor at room 41. it has a wooden parquet floor which is typical throughout the library and should be repaired and retained.

There are matching pilasters and shallow beams to room 41.

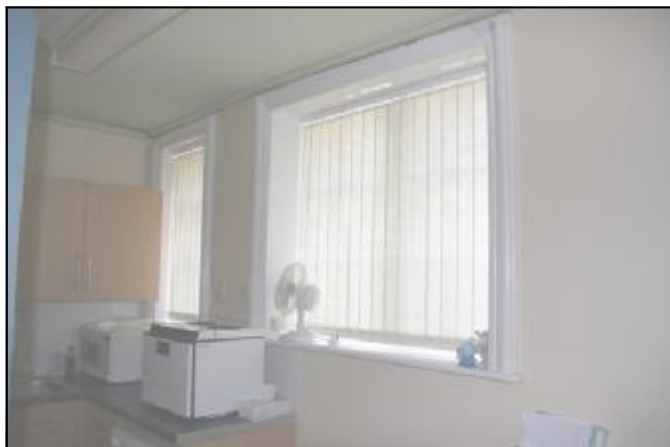
Presently a small office this room retains nothing of any originality apart from the window which is presumed to be original.

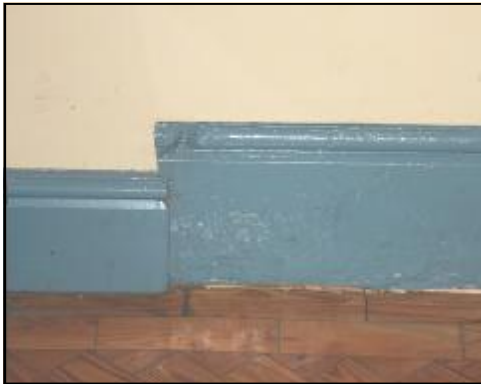
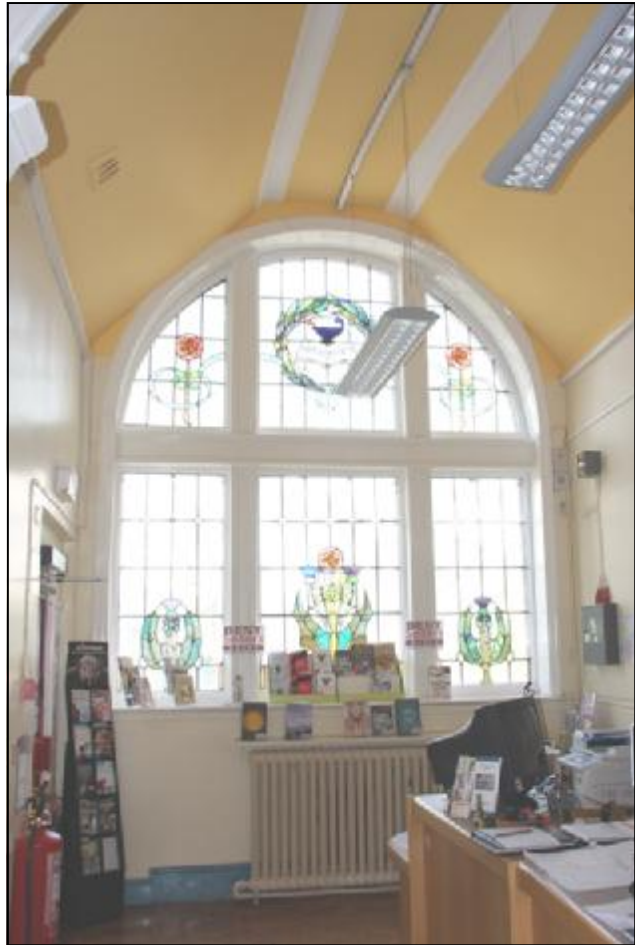
The room contains the librarians' desk and is the books checking in & out point. The desk is modern. The detailing of plasterwork is thought to be much as originally intended although some changes have been made and should be repaired. There is some alteration evident to skirtings. The picture below shows the original, probably plaster or concrete, with the newer timber skirtings.

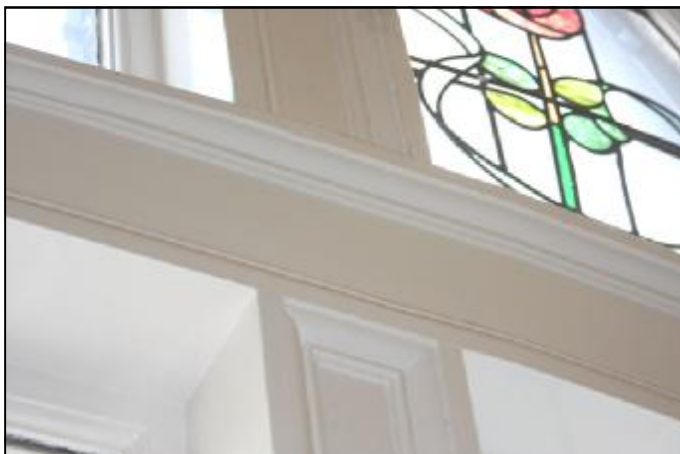
Detail of plastered stone mullions and transoms to window

The room is well lit by a large arched window with leaded glass; the roof is carried on exposed timber frames springing from stone corbels. The ceiling is consequently high with panels in the plane of the roof rising to a flat centre panel beneath the ridge. Various plaster details have been retained as shown on the next page.

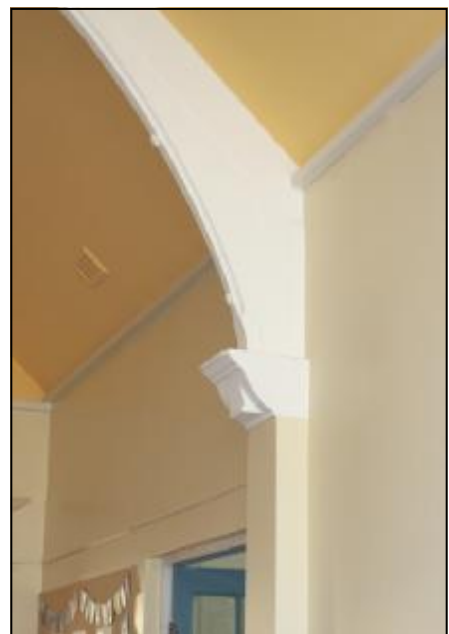
Plaster detail over room partition from room forty-seven to room fifty-one.

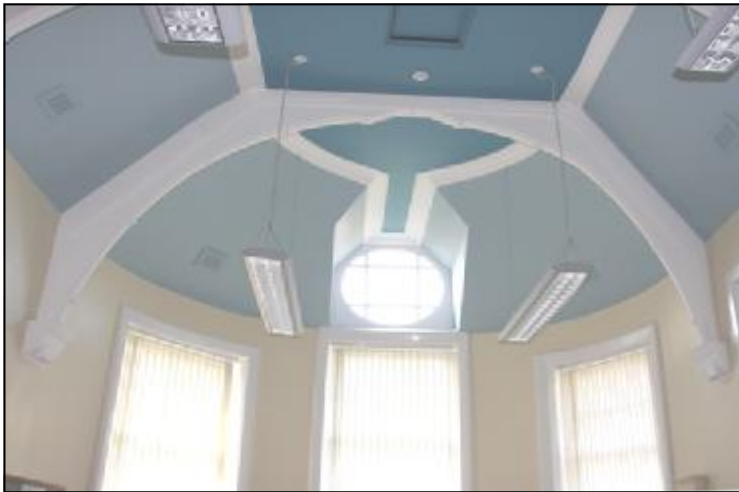
This room is one of the two rooms in the library which have a semi-circular end wall. The ceiling detail shows a circular window in the roof and the exposed timber roof truss supported on stone corbels. There are two original air vents to either side. Room fifty is a store room accessed to the right hand side from the entrance doorway. This has an original leaded window.

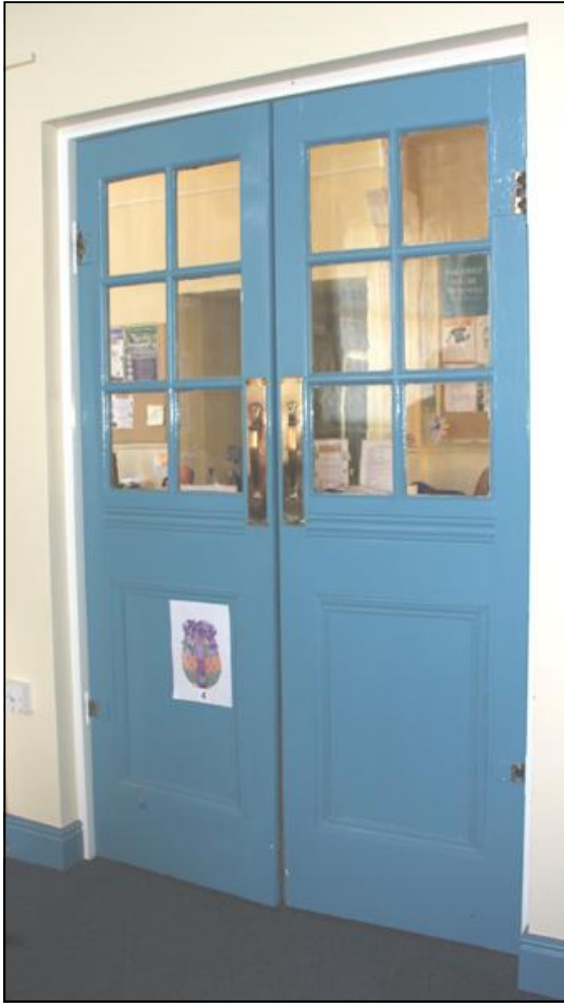
The entrance door is probably original and should be retained along with the door furniture, although some amendment will probably be needed i.e. the door handles are not handed to left and right. The double swing hinges are also probably not original as there is evidence that the earlier hinges were larger.

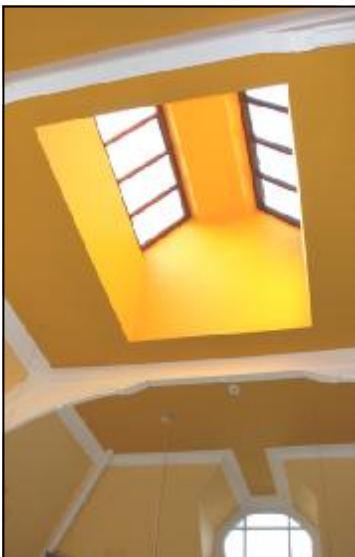
This room connects rooms forty-seven and fifty-two. It contains many details which occur in adjacent rooms but has a roof lantern, one of a number of additional windows which increase the amount of light which give the rooms such a pleasant ambience. Further additional lighting from a clerestory window seen on the right.

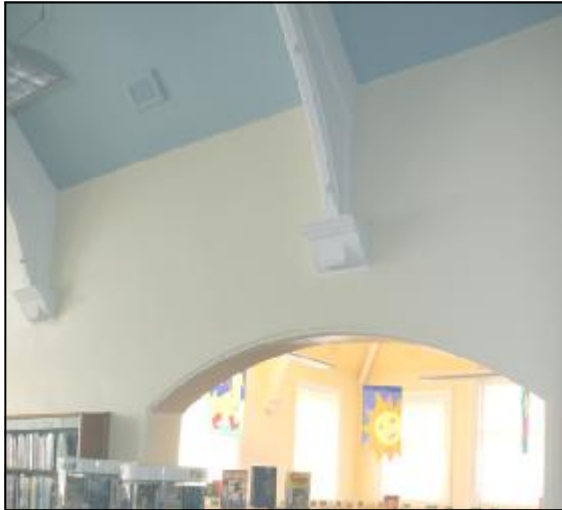
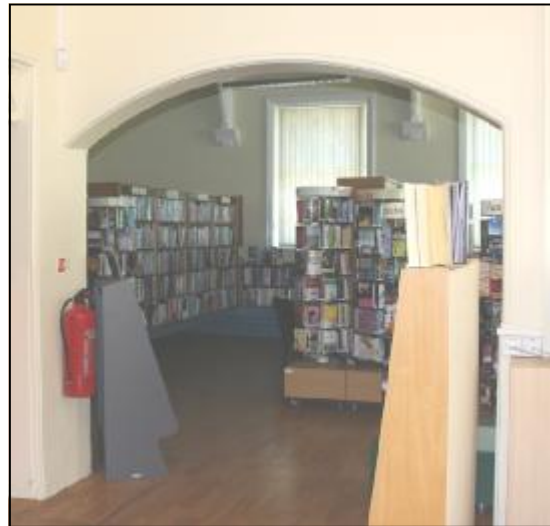
This room is the largest and is accessed from room fifty-one through this arched opening shown on the right.

The opening supports one roof truss within the room as shown on the left.

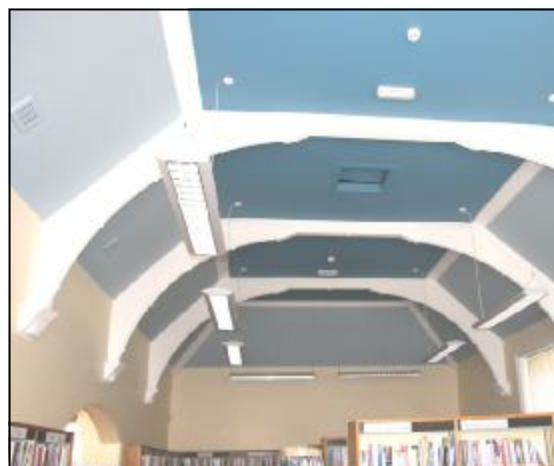
The ceiling has a wider span than that in room forty-nine with a consequent increase in the size of the central part of the ceiling. The trapdoor is thought to lead to a roof space which originally gave access to a large ornate roof built on the roof ridge.
